Chapter 4 – Unit Improvements - Whole House

4.1 Unit Improvements Overview

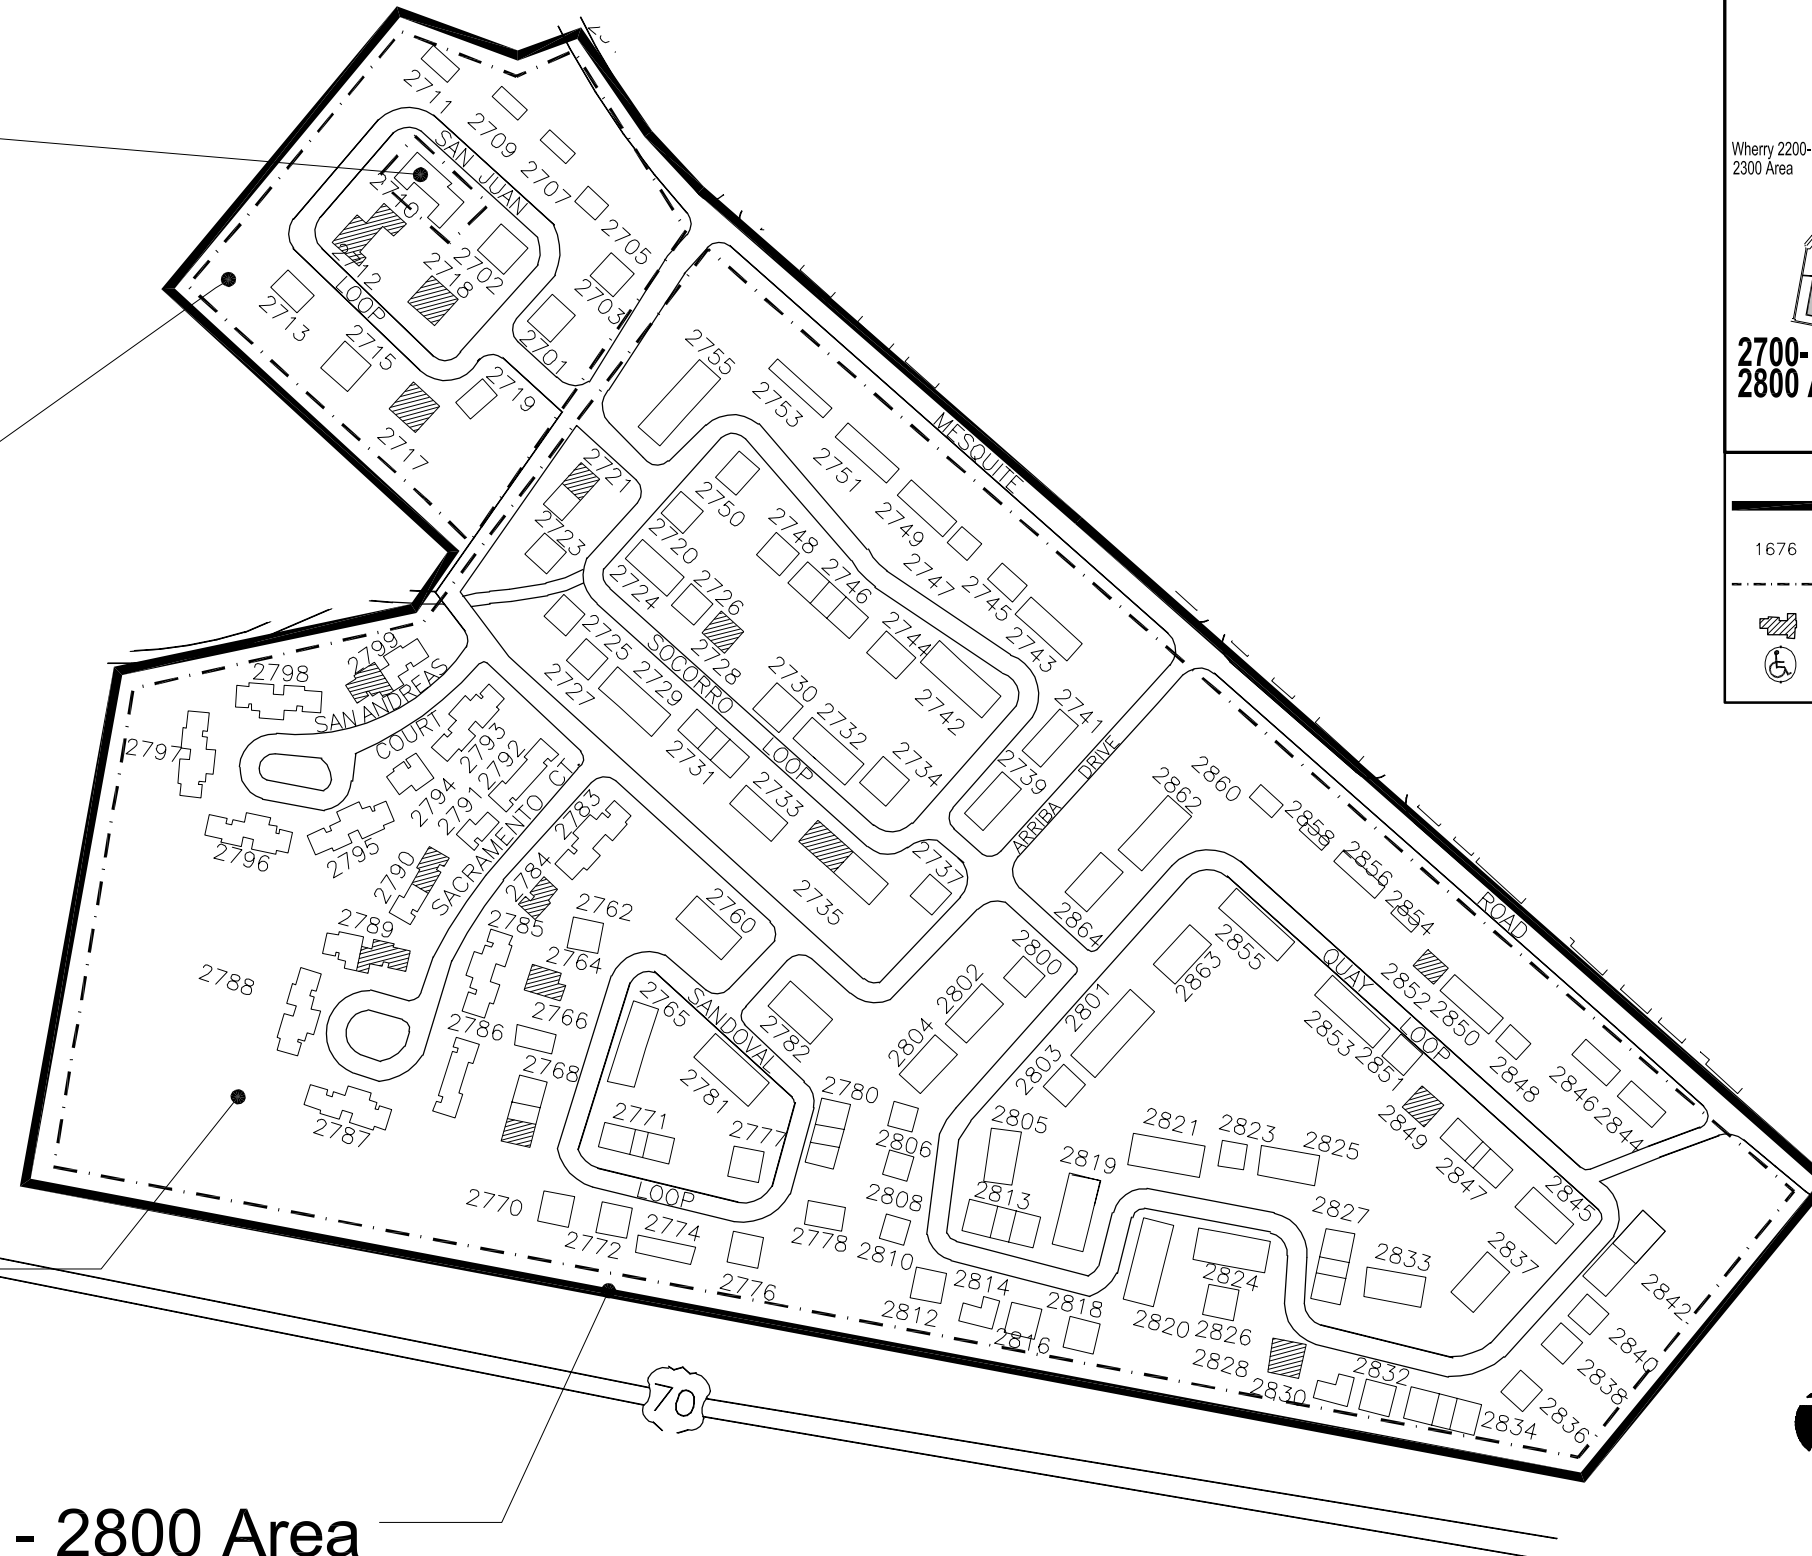
**Existing Unit Grade Mix Plan -
2700-2800 Area**

90 - 3 BEDROOM CGO
36 - 4 BEDROOM CGO
43 - 3 BEDROOM FGO
7 - 4 BEDROOM FGO

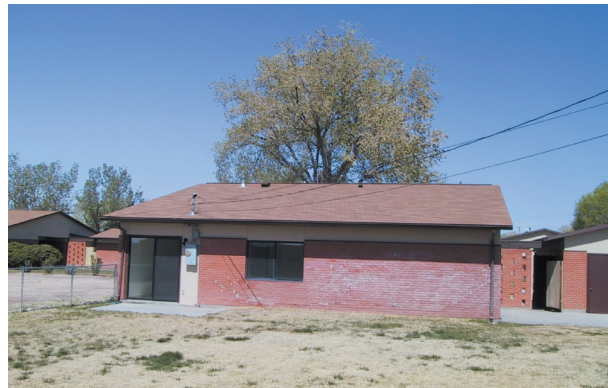
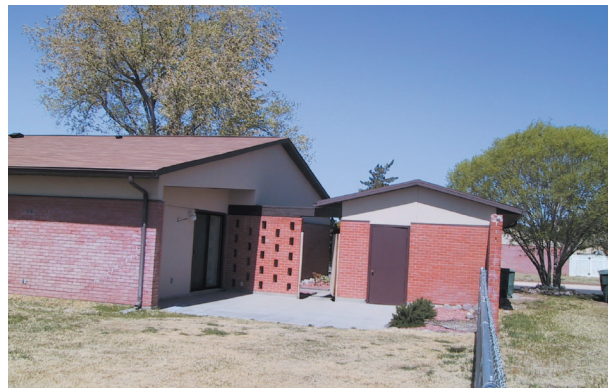
Rear elevation

- Exterior Wall Structure: wood frame; good condition.
- Exterior Wall Covering: brick veneer; fair condition; it appears that 20% of grade is near or above the concrete floor slab and against the brick; water has weeped up the wall carrying the alkali from the soil and transferred it to the brick and mortar; the cause has been deterioration of the mortar and discoloration of the brick; no counter flashing or weep holes visible in the brick.

- Doors - Sliding Glass: aluminum; fair condition; the sliding glass door at the Living Room and at the Family Room have oxidation of finish and no secondary locking device.

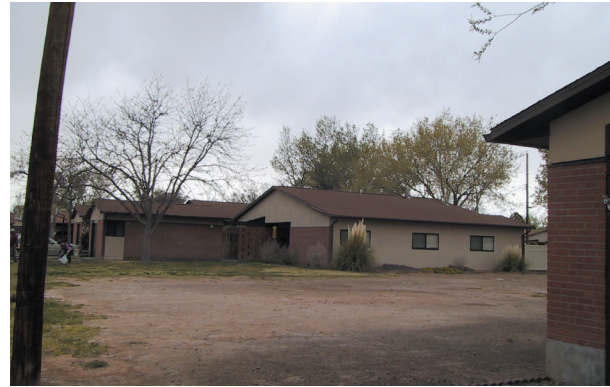
Right side elevation

- Exterior Wall Structure: wood frame; good condition.
- Exterior Wall Covering: brick veneer; fair condition; deteriorating 25% of mortar joints; stucco is in good condition.
- Foundation/Basement: slab on grade; good condition.
- Floor Structure: none; slab on grade.
- Windows - Frames: aluminum; good condition; minor corrosion of window finish from high alkali soil content.
- Windows - Glazing: double; good condition; bedroom windows provide emergency egress.
- Windows - Screens: aluminum; good condition.
- Doors - Entry: metal; good condition.
- Doors - Sliding Glass: aluminum; good condition; no secondary locking device.
- Doors - Storm/Screen: aluminum; good condition.
- Doors - Hardware: brass; fair condition; no dead bolt on exterior doors.

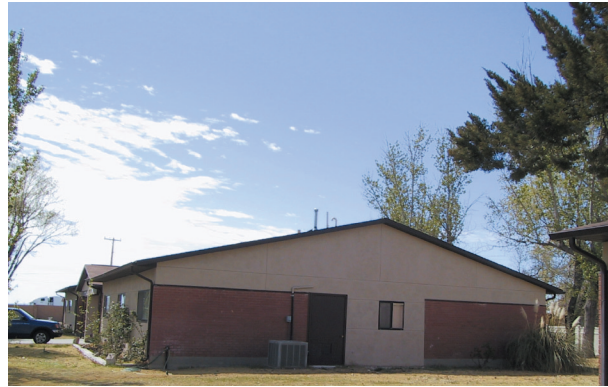
Right side elevation

- Exterior Wall Structure: wood frame; good condition.
- Exterior Wall Covering: stucco; fair condition; minor cracks over 10% of exterior; brick in fair condition; brick is discolored at bottom 1/3 of entire unit.
- Foundation/Basement: slab on grade; good condition.
- Floor Structure: none; slab on grade.
- Windows - Frames: aluminum; good condition.
- Windows - Glazing: double; good condition; bedroom windows meet minimum egress requirements.
- Windows - Screens: aluminum, good condition.
- Doors - Entry: metal; good condition.
- Doors - Sliding Glass: metal; fair condition; at family and living rooms; frame corroded; no secondary locking devices.
- Doors - Storm/Screen: none; required.
- Doors - Hardware: brass; fair condition; entry door does not have dead bolt.
